Assessment of the Processing Capacity and Capability of the Newport Facility

Project I.D.: 15R002.02

**Ramsey/Washington Recycling and Energy Board
(fka) Ramsey/Washington Resource Recovery Project Board**

November 2015

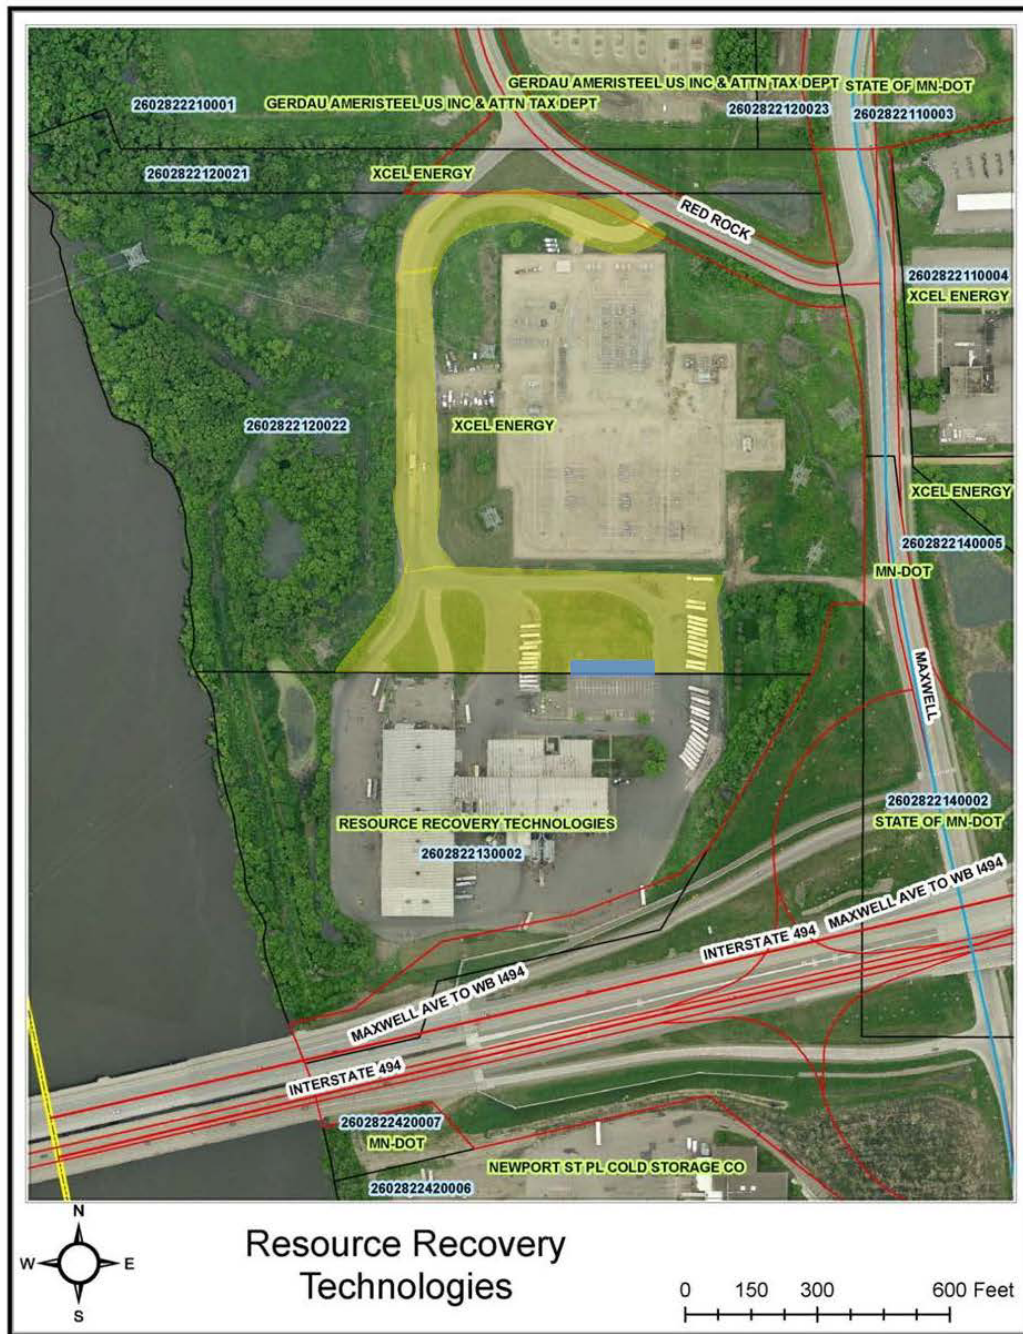
**Figure 2-1
Newport Facility & Surrounding Properties**

A Facility site layout showing the 14-acre parcel of land, buildings and associated support facilities (scales, etc.) is provided as Figure 2-1 (includes adjoining properties). Figure 2-1 also shows the areas covered by the Easement Agreement and License Agreement between RRT and Xcel.

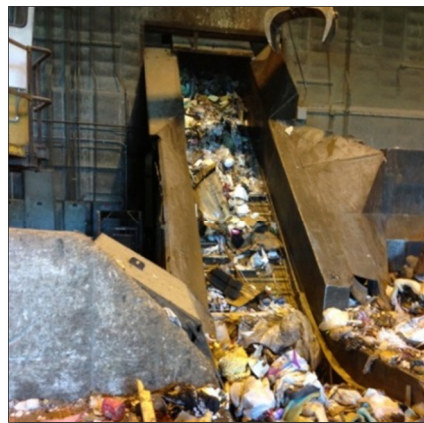
Photograph 1: In-feed Pit and Inclined Conveyors

A submerged conveyor is located in a pit in the tipping floor for loading MSW with a front end loader. The other conveyor is inclined and conveys the MSW into the hammer mill. Photograph 1 shows the in-feed pit and inclined conveyors located in the tipping floor area adjacent to the grapples.

The first conveyor is a metal pan conveyor with a horizontal “pit” section made of metal trays carried between roller chains. This conveyor must absorb the impact of material dropped onto it from the front end loaders as well as impacts from the grapple as the grapple picks out material not appropriate (large metal items, inerts, bulky waste, etc.) for RDF production. The second conveyor is an inclined, metal tray clefted conveyor that conveys and elevates the material into the hammer mill. The inclined conveyor is prone to abrasive wear due to the types of material it must convey, the inclined nature of its application, and exposure to fires and explosions that may occur in the hammer mill.

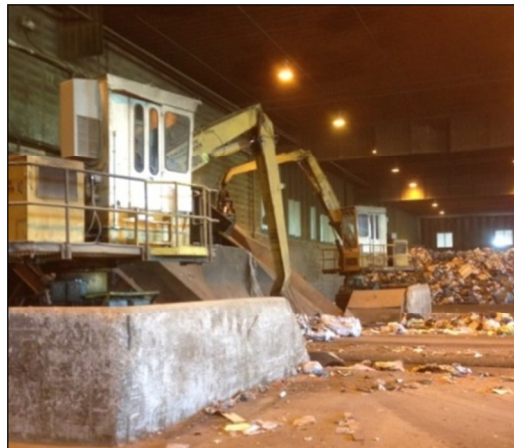
Photograph 2: Grapple Cranes on A and B Lines

Built-Rite 2100 stationary electric grapple cranes are positioned near the metal pan in-feed conveyor and near the bulky waste shear shredder and conveyor for the trash load out. Photograph 2 shows the grapple cranes for both A and B lines.

The grapple cranes are built by North Shore/Built Rite and are generally stock single boom, pivoting, hydraulic cranes equipped with a grapple attachment. At A and B lines, the grapples are used to pick up and remove items that cannot be processed into RDF that is placed on the in-feed conveyor by the front end loaders. The front end loaders transfer the removed items to a staging area near the third grapple where the grapple can load the material into either the shear shredder or the in-feed conveyor for trash load out. The grapple cranes are also used to spread out the piles of MSW on the in-feed conveyor for a more uniform flow of MSW into the hammer mill.

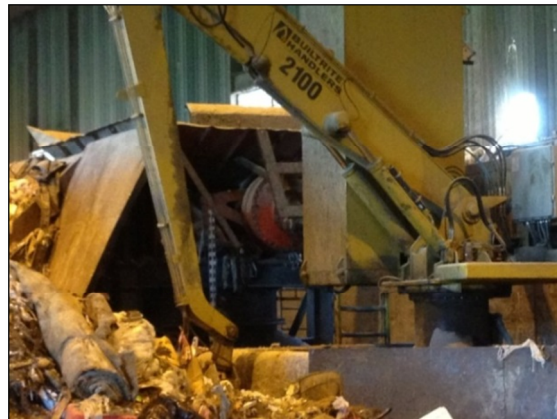
Photograph 3: Grapple and Bulky Waste Shear Shredder

The bulky waste shear shredder is loaded with sorted MSW (i.e. bulky waste) by the grapple. The bulky waste shear shredder operates at a slow speed (unlike the hammer mills), reduces the size of the material and drops it on to the discharge conveyor. The discharge belt conveyor is loaded with size reduced material and conveys the material to a pile on the tipping floor. Currently the Bulky Waste shear shredder is being used to size reduce mattresses prior to loading them into the trash load out conveyor. Photograph 3 shows the grapple crane (foreground) and bulky waste shear shredder (back ground).

The bulky waste shear shredder was designed based on extensive input from RRT and relies upon specially designed cutters attached to rotors that are positioned within a metal frame with a narrow tolerance (between frame and rotor). This allows the Shredder to shear, tear, and fracture material that enters the Shredder. Staff at RRT indicated that the shredder was built and put into operation in 1999 and had a major overhaul in 2013. The shredder receives over-sized, heavy, bulky components of MSW from the grapple crane and must shred the material in order to reduce the size.

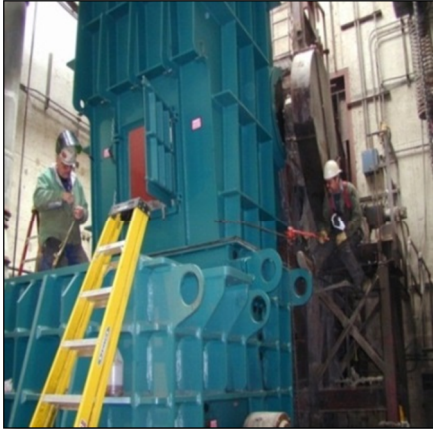
Photograph 4: Hammer Mill

The primary hammer mill is designed to reduce the physical size of the MSW for further processing. Reducing the physical size may include tearing open packaged MSW and reducing the contents of the package to the correct size. There are two (2) primary hammer mills operating at the facility (i.e., at A and B lines). Photographs 4 and 5 show the primary hammer mill within the concrete structure and the rotor that is housed in the primary hammer mill.

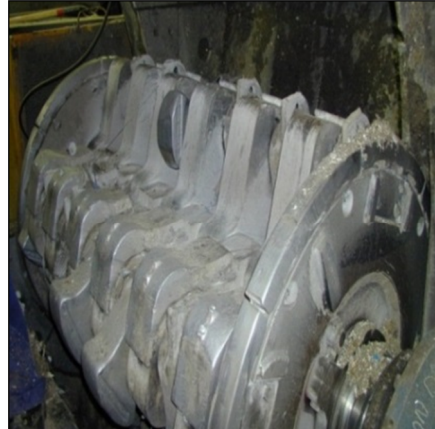
Photograph 5: Rotor

Several of the processing steps use the physical size (i.e., length, width, and height) of the pieces of MSW to accomplish their task. Steps like disc screening, air classification, magnetic separation, and aluminum separation all work more efficiently when small pieces are provided. Therefore, size reduction by the primary hammer mill is essential to effective material processing through A and B lines and efficient removal of ferrous, non-ferrous metals and grit. Size reduction is accomplished by rotating a large diameter rotor that has hammers attached using pins. The pins allow the hammers to swing as the rotor is turned, which in turn crushes or grinds material between the hammer and slotted grating and resizes the material.

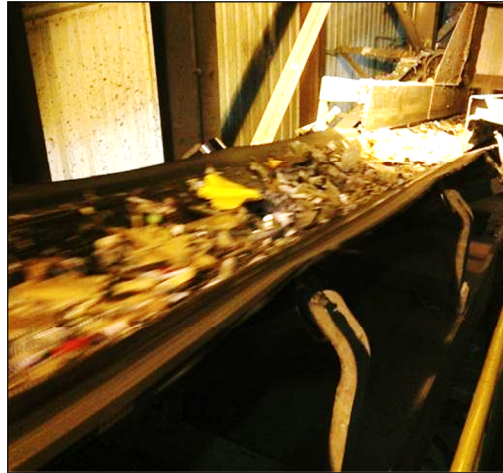
Photograph 6: Typical Troughed Roller Bed Belt Conveyor

These belt conveyors have the most severe duty due to the size, weight, and composition of material placed on them. However, their operation is not as critical to RDF production as the conveyors on A and B lines. Photograph 6 shows a typical troughed roller bed belt conveyor used at various locations throughout the Facility.

Troughed roller bed belt conveyors transport material from operation to operation starting at the discharge of the hammer mill and ending at the RDF load out. They are also used to convey non-ferrous metals to the baler, and debris to the trailer loading system.

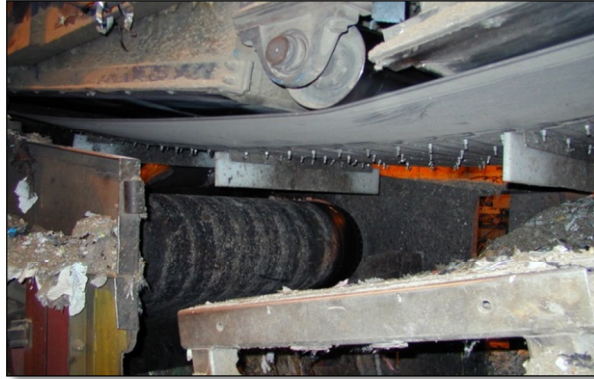
Photograph 7: Magnetic Separator

The magnetic separator at the Facility is a Dings Co. magnetic belt separator. This separator removes ferrous metal pieces from the processed MSW after processing through the primary hammer mill. The sorted ferrous metals are transferred to a sliding belt conveyor where the material is conveyed to a second clean up magnet. Photograph 7 shows a magnetic separator at the Newport Facility.

Ferrous metal within the partially processed MSW exiting the hammer mill must be removed, not only because the material will cause problems at the Xcel plants, but because there is a market for the material. On the end of the hammer mill discharge conveyor, suspended over the discharge belt is the magnetic belt conveyor. Ferrous material in the MSW stream is attracted to the magnet and “sticks” to the belt. The belt conveys the ferrous materials to the end of the discharge conveyor, where the magnet releases the materials onto a ferrous conveyor. The MSW free of or mostly free of ferrous materials is deposited onto the primary disc screen. The magnet must be operating when the hammer mill discharge conveyor operates.

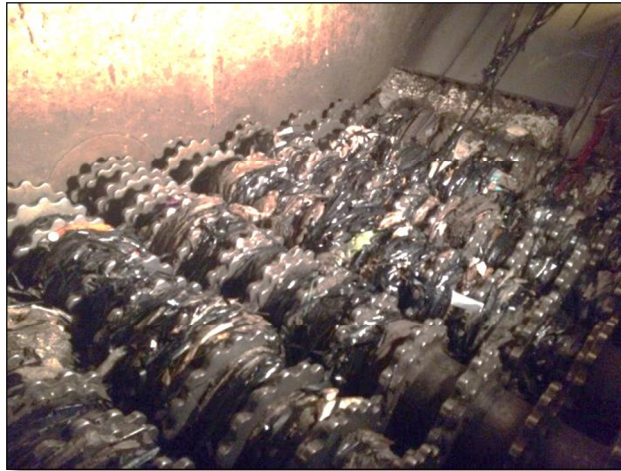
Photograph 8: Primary Disc Screen

The primary disc screen is a Jeffrey Rader brand disc screen. It is used to sort material by particle size that has passed through the magnetic separator. Photograph 8 is a representative photograph that shows the interior offset discs which allow smaller materials to fall between the rotor and discs.

As shown in Photograph 8, the primary disc screen is used for sorting by particle size. The primary disc screen has rows of rotating wheels (“discs”) at an incline that are in line with each other to allow smaller material (in this case under six (6) inches) to fall between the discs and larger material (over six (6) inches) to be carried along each set of rotating discs until the material reaches the discharge roller. The fraction under six (6) inches goes to the secondary disc screen and the fraction over six (6) inches goes to the air classifier.

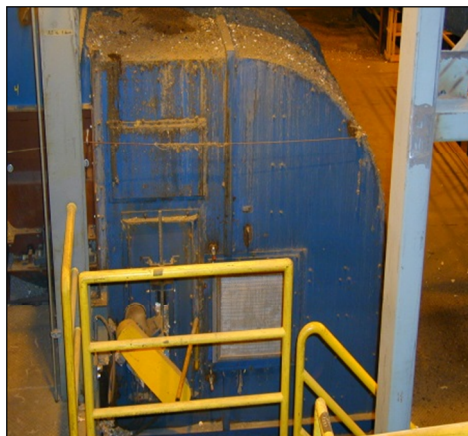
Photograph 9: Air Classifier

RRT indicated that the air classifier is a custom built piece of equipment, but assembled using “off the shelf” components. Similar in function to the primary disc screen it is used to sort material, but it is designed to separate materials based on the density (weight) of the materials rather than sorting based on size. Photograph 9 shows the exterior of the air classifier.

The air classifier uses the forward velocity of the material leaving the primary disc screen in conjunction with an upward air flow to force light (low density) material to “float” while heavy (high density) materials “fall” onto a debris conveyor. This action provides two material streams, one with “light” materials and one with “heavy” materials. Heavy materials at this stage of processing are considered not suitable for RDF, and are conveyed to process residue loadout to be landfilled. Light materials are conveyed to the secondary shredder for additional processing.

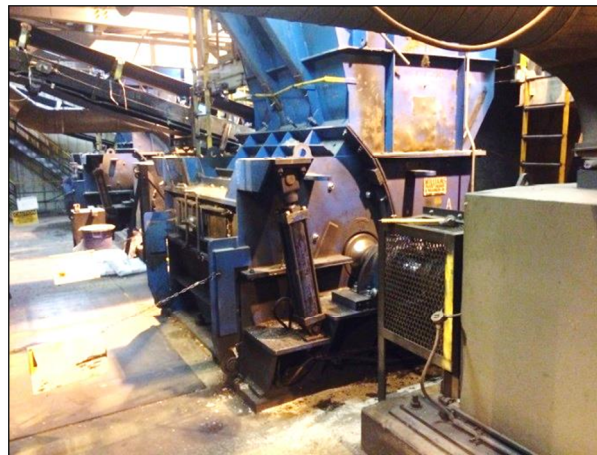
Photograph 10: Secondary Shredder

The secondary shredder is a Williams Crusher hammer mill that has been modified by RRT after years of experience. The shredder is designed to reduce the size of the air classified “overs” to pieces five (5) inches or smaller in any dimension in order to meet the specifications for RDF established by Xcel. Photograph 10 shows the secondary shredder.

This shredder is similar in function and operation to the primary hammer mill (size reduction) previously discussed. The unit is physically smaller and operates with an 800 hp motor. The material entering the secondary shredder is already processed MSW that only needs to be resized to satisfy the RDF specifications set by Xcel. This is the final processing step for the MSW to meet RDF specifications and material leaving this operation is ready for loading into trailers.

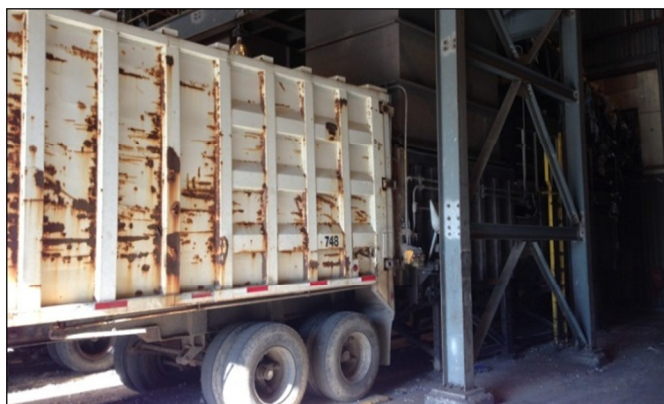
Photograph 11: RDF Compactor/Loader

The compactor/loaders are used to fill the trailers leaving the Newport Facility and are used to make sure that the trailers are at their maximum capacity. The compactors at the Facility have undergone some modification to the hydraulic system, but would still be considered generally an “off-the-shelf” piece of equipment. Photograph 11 shows the RDF compactor/loader with a trailer being filled from one of the processing lines.

Each line has two compactor/loaders and two trailer loading stations (i.e. four (4) trailers can be parked and filled). Each processing line has a mass flow scale that records the amount of RDF flowing into a compactor/loader. The control room operator is responsible for loading trailers to the prescribed weight with one compactor/loader, and transfers the loading to the second compactor/loader without interruption to the flow of RDF. He then notifies the yard truck operator when the full trailer can be removed, weighed and replaced with an empty trailer. Upon completion the control room operator is notified by the yard truck operator that the compactor/loader is ready with an empty trailer.
- Maintenance History:**

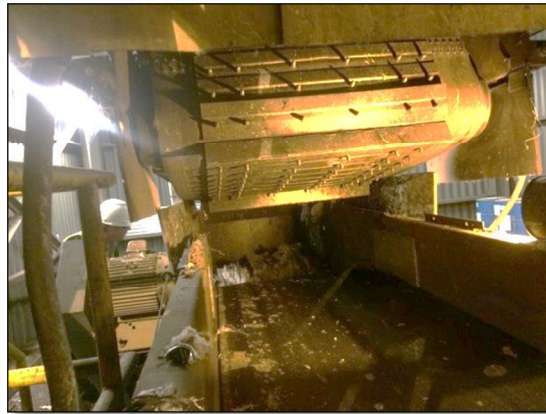
Photograph 12: Second Cleanup Magnet

The second cleanup magnet is similar to the magnetic belt separator. The second cleanup magnet removes ferrous metal pieces from the material leaving the magnetic belt separator. Photograph 12 shows a magnetic separator at the facility and is representative of the second cleanup magnet.

Ferrous material sorted from the processed MSW by the magnetic separator is conveyed by slider bed conveyor to the secondary cleanup magnet. This magnet is similar in construction and operation to the main magnetic separator. In this case, ferrous metal pieces that are fairly or completely free of other materials are attracted to the magnet, leaving ferrous pieces that have non-ferrous materials attached to them. The pieces of “clean” ferrous are conveyed via chute to the “clean ferrous loadout” and sold. The remaining ferrous material is considered to be “dirty” and is diverted to the “dirty ferrous loadout” and sold at a lower price than “clean ferrous”.

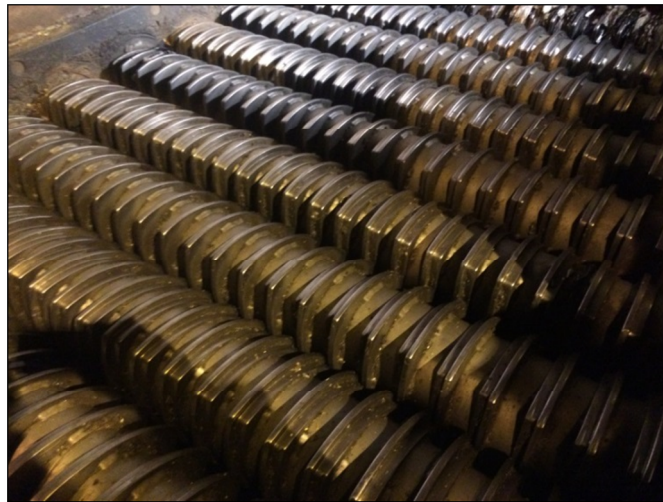
Photograph 13: Secondary Disc Screen

The function of the secondary disc screen is similar to the primary disc screen; sorting material based on size. Photograph 13 is a photograph that shows the rotors and discs of the secondary disc screen.

The secondary disc screen receives the material six (6) inches and smaller from the primary disc screen as well as low density material from the secondary shredder that has passed through the air classifier and sorts the material at the two (2) inch size. Greater than two (2) inch material is considered RDF, and less than two (2) inch goes to the secondary air classifier.

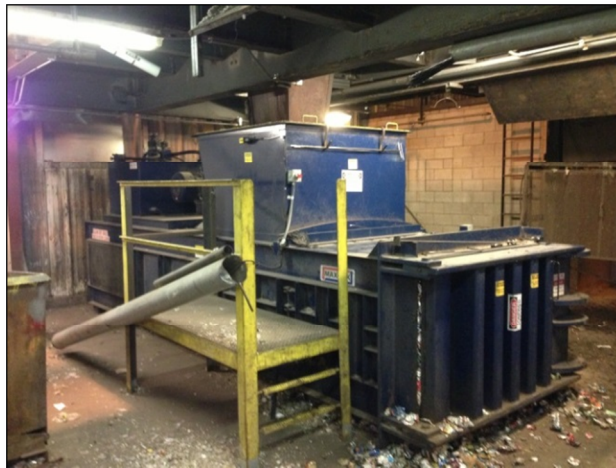
**Photograph 15
Aluminum Baler**

Aluminum materials sorted out of the RDF processing stream on each line are conveyed to a common baler for compacting into a bale. The baler at the Facility is a Max-pak horizontal baler and is shown in photograph 15.

Aluminum removed from the processed material is conveyed to an in-feed hopper on the top of the aluminum baler. Once there is enough aluminum in the baler, a hydraulic ram pushes a plate against a fixed portion to compact the aluminum into a bale. The bales must be manually tied with wire to hold the bales together. The bale is removed and is stored, ready for sale.
